WOOD DESTROYING PESTS AND ORGANISMS INSPECTION REPORT

BUILDING NO. 73	STREET, CITY, STATE, ZIP Sommer Ln , Goleta CA 93117	Date of Inspection 2/5/2018	No. of Pages 4
--------------------	---	--------------------------------	-------------------

General Description: Two story stucco frame residence, tile roof, concrete slab, attached garage.	Inspection Tag Posted: Attic
	Other Tags Posted:

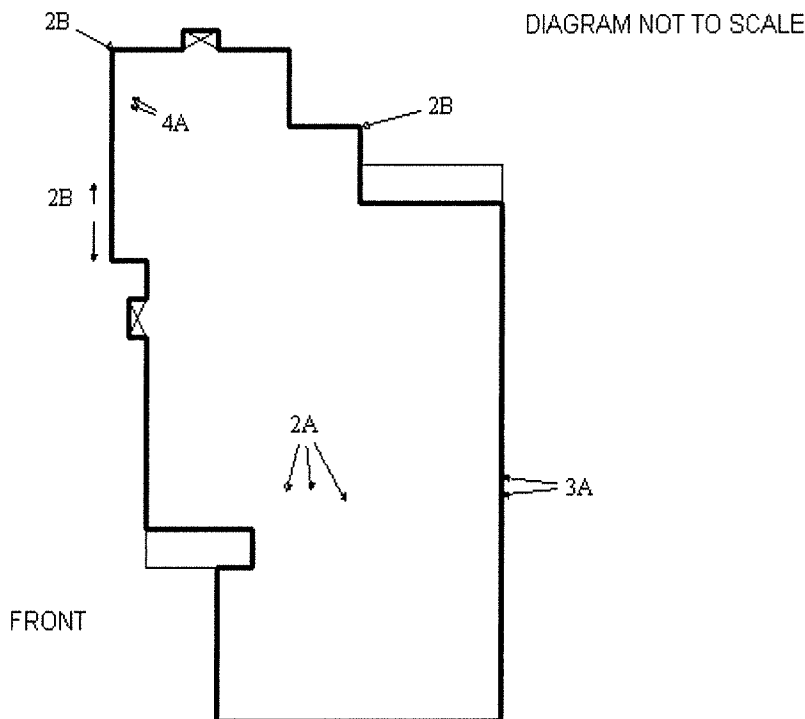
ITEM 2A **Finding:** Evidence of drywood termites found at the attic and exterior as indicated on the diagram by 2A. Infestations appear to extend into inaccessible areas.

ITEM 2B **Finding:** Drywood termite damage found at the barge rafters and fascia board as indicated on the diagram by 2B.

ITEM 3A **Finding:** Dry rot damage found at the exterior garage door frames as indicated on the diagram by 3A.

ITEM 4A **Finding:** Moisture stains and moisture warping found at the stall shower and wall adjacent to the master shower as indicated on the diagram by 4A.

Recommendation: Vacate and seal the structure. Fumigate with Vikane or Master Fume (Sulfuryl Fluoride) and Chloropicrin (warning agent) for the extermination of drywood termites. Remove seal, air out the building, ready for occupancy. When possible, remove or cover accessible evidence. This company will not be liable for possible damage to plants, paint, roofs, T.V. antennas; reasonable care will be exercised. Fumigation cannot take place in strong winds or rain and will be rescheduled if there is inclement weather.

2B-1 Recommendation: Remove damaged areas and repair with new material and/or wood filler as necessary. Ready for painter.

2B-2 Recommendation: After completion of 2B-1, we recommend others to contact a licensed gutter specialist, if necessary, to inspect and make necessary corrections.

Recommendation: Remove damaged area and replace with new material. Ready for painter.

Recommendation: Any questions regarding this condition should be referred to a licensed contractor.
